New deep groove ball bearings high frequencies vibration testing

V. Barzdaitis*, V. V. Barzdaitis**, R. Maskvytis***, A. Tadžijėvas****, M. Vasylius*****

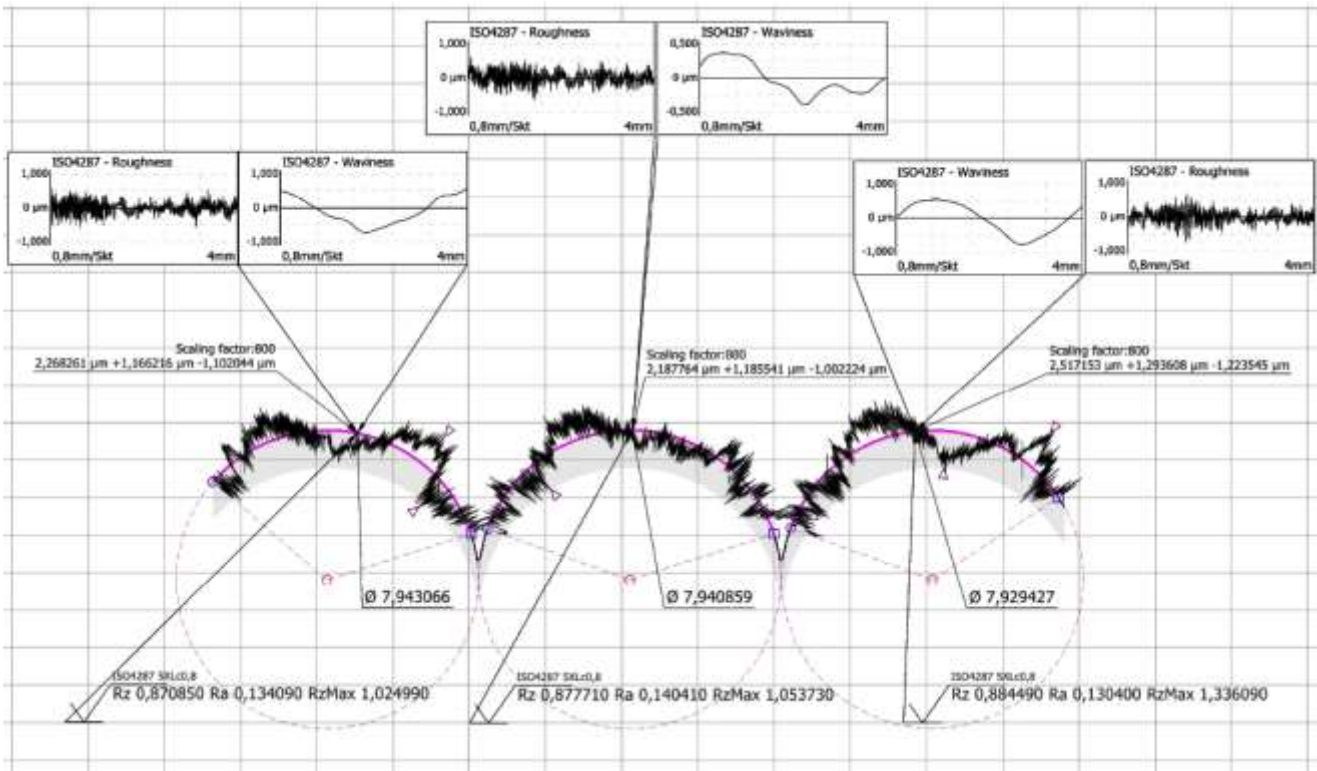
Fig. 1 Bearing balls geometric dimensions: roughness R_a , R_z , R_{zMax} and waviness W_s values of three balls of the tested bearing; balls' nominal diameter (7.933 ± 0.0004 mm) with deviations: 7.943066 mm ($2.266 \mu\text{m}$); 7.940859 mm ($2.18764 \mu\text{m}$); 7.929427 mm ($2.517153 \mu\text{m}$); micro-defects (surface roughness R_z 0.87085-0.88449 μm , R_{zmax} 1.02499-1.33609 μm) and waviness $W_s < \pm 0.5 \mu\text{m}$ (by courtesy of Craft Bearing Corp.)

6. Tested bearings contacting elements with the surfaces roughness R_z , R_{zmax} , waviness W_s , misaligned races and off-size rolling elements, roundness' were measured with high quality devices disassembling tested bearings, (Fig. 1). Measurements of inner raceway, outer raceway and balls roundness, waviness and roughness were provided with high accuracy measurement devices. Bearing 6205 C3P6 elements measurement results indicated the existence of micro-defects (surface roughness R_z , R_{zmax} , R_a waviness W_s) in the new bearing elements (Fig. 1, Table).

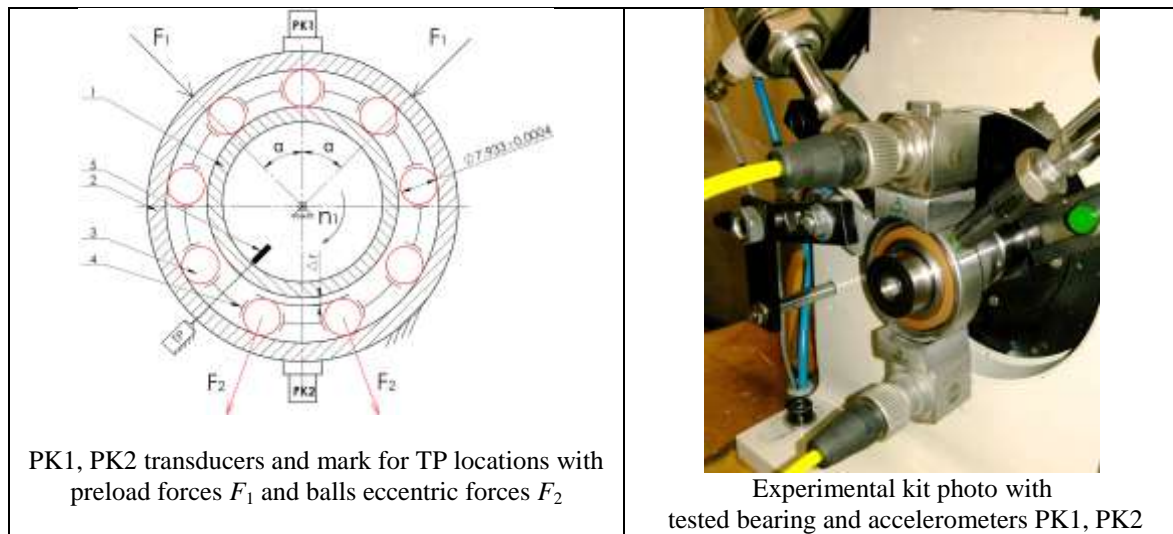
Fig. 2 Bearing 6205 C3P6 vibration acceleration measurement scheme and rotor kit photo: two accelerometers PK1, PK2; preloads F_1 forces with angle α ; F_2 are the balls eccentric inertia forces, inner ring 1, outer ring 2, balls 3, cage 4, non-contact tachometer probe with TP mark on the shaft 5; $\Delta r = 13-18$ μm is the radial internal clearance, $n_1 = 1800$ r/min is rotational speed of the shaft with bearing's inner ring

Two external preload radial forces $F_1 = 100$ N values were each loaded at the stationary outer ring. F_1 added symmetrically reference to the first accelerometer PK1 location in order to measure bearing's outer-inner raceways contacts with balls excited vibration (Fig. 2). These forces guarantee permanent dynamic contact between rolling elements at PK1 transducer location. Radial external forces F_1 values were limited by minimum frictional moment ($M = \sim 0.5 \mu F_1 d = 3.75$ N mm) in the bearing elements ($\mu = 0.0015$ is the coefficient of friction for the deep groove ball bearing, d is bearing ball diameter). The second accelerometer PK2 measures bearing outer ring raceway contact with balls excited vibration. The balls are in permanent contact with outer raceway at the PK2 attached location. The existing nominal radial internal clearance Δr between inner raceway and balls are guaranteed by this loading scheme. Such vibration measurement method with two accelerometers and external loading al-

where $m_r = 0.00355$ kg is the mass of the ball 4 (Fig. 2); $\omega_{cage} = 74.84$ 1/s, cage with balls angular velocity about shaft axis, cage radius of rotation $\frac{1}{2} d_m = \frac{1}{2} \cdot 0.0385 = 0.01925$ m, $d_m = (d + D)/2 = 0.0385$ m is the mean diam-

The balls are in permanent contacts with inner and outer raceways at the same time at the accelerometer PK1 attached location. These dynamic contacts between bearing elements generate high frequency vibration acceleration proportional to micro-defects values existing in both raceways and balls. Preloading forces F_1 pushed outer ring through balls to inner ring eliminating radial internal clearance Δr at the transducer PK1 location. At the same time, the radial internal clearance Δr between balls and inner raceway exists during rotation at the PK2 transducer location, because ball mass eccentric F_2 force pushes each ball towards the outer raceway (Fig. 2). The balls at the accelerometer PK2 attached location are in permanent contacts only with the outer raceway, but not with the inner raceway. The high frequency vibration generated by these contacting elements with micro-defects describes manufacturing technological quality of the outer ring raceway and balls. The radial internal clearance of the tested 6205 C3P6 bearings according ISO 5753:1991 are of 13 - 28 μm value.

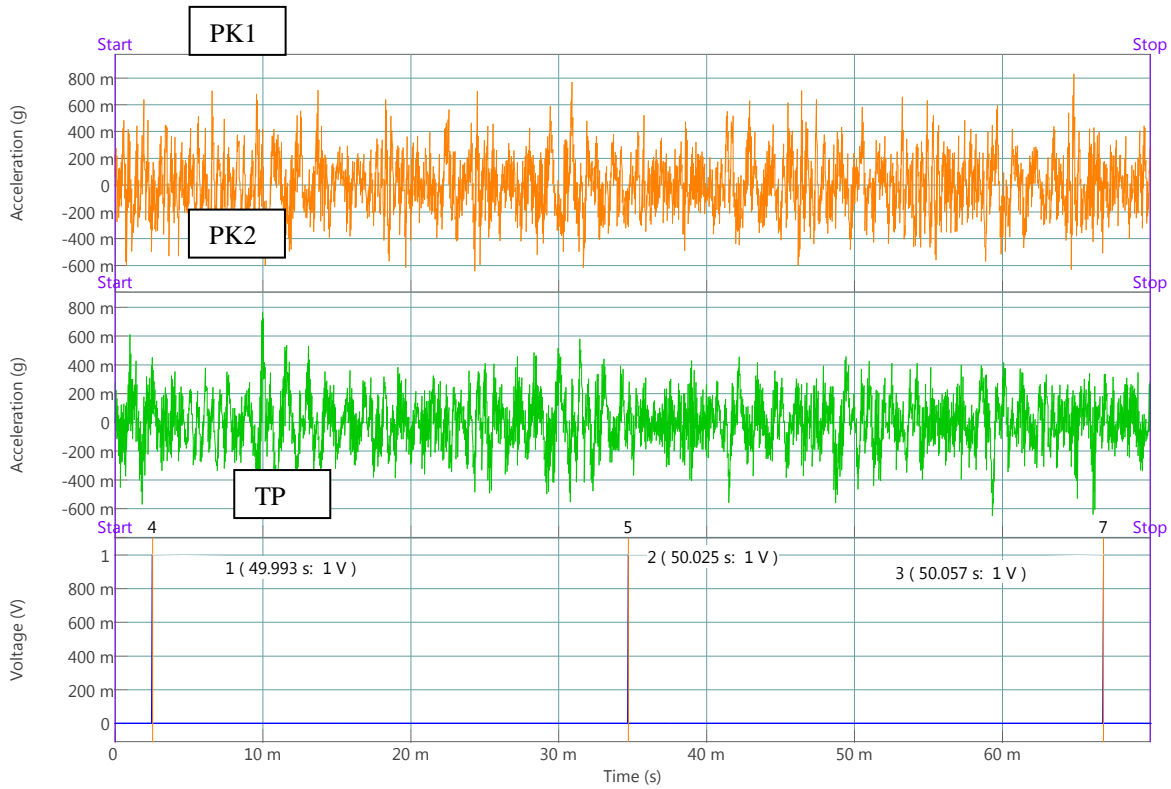
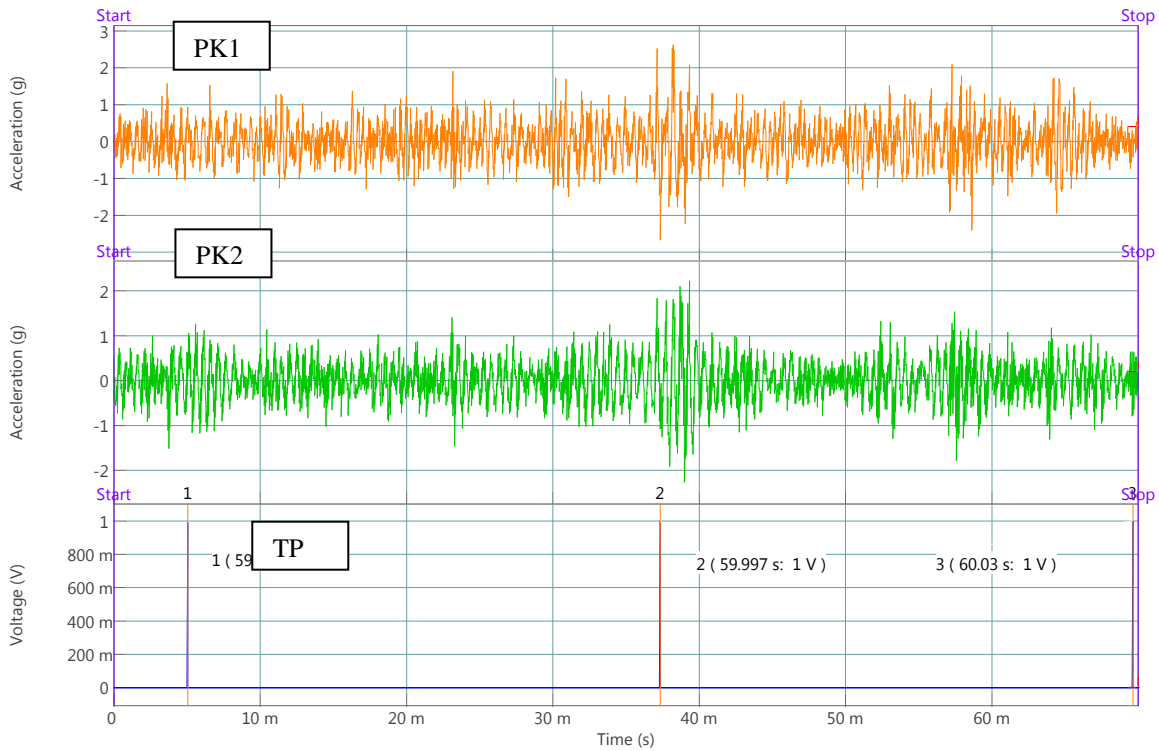
Fig. 3 Vibration acceleration time base plots during two full rotations of inner raceway with grease lubricated (a) and without grease lubricant (b) bearing with preloads $F_1=100$ N: PK1 transducer output upper and PK2 transducer output lower plots, TP is tachometer probe output

Bearing vibration was measured when acting with preloading forces F_1 and vibration acceleration-time base plots shown in (Fig. 3). TP signals indicated each full rotation time (0.0333 s) of bearing inner ring. The maximum acceleration magnitude value of the bearing with grease lubricant reached $a_{p-max} = \sim 1.2$ m/s^2 and was ~ 2.5 times less in comparison with dry bearing vibration acceleration $a_{p-max} = \sim 3$ m/s^2 (Fig. 3, a, b).

With grease and preloads $F_1 = 100$ N bearing vibration acceleration magnitudes are 2-2.5 times greater at accelerometer PK1 measurement location in comparison with PK2 data, as ball shocks at outer and inner raceways were more intensive in comparison with outer raceway at PK2 accelerometer location.

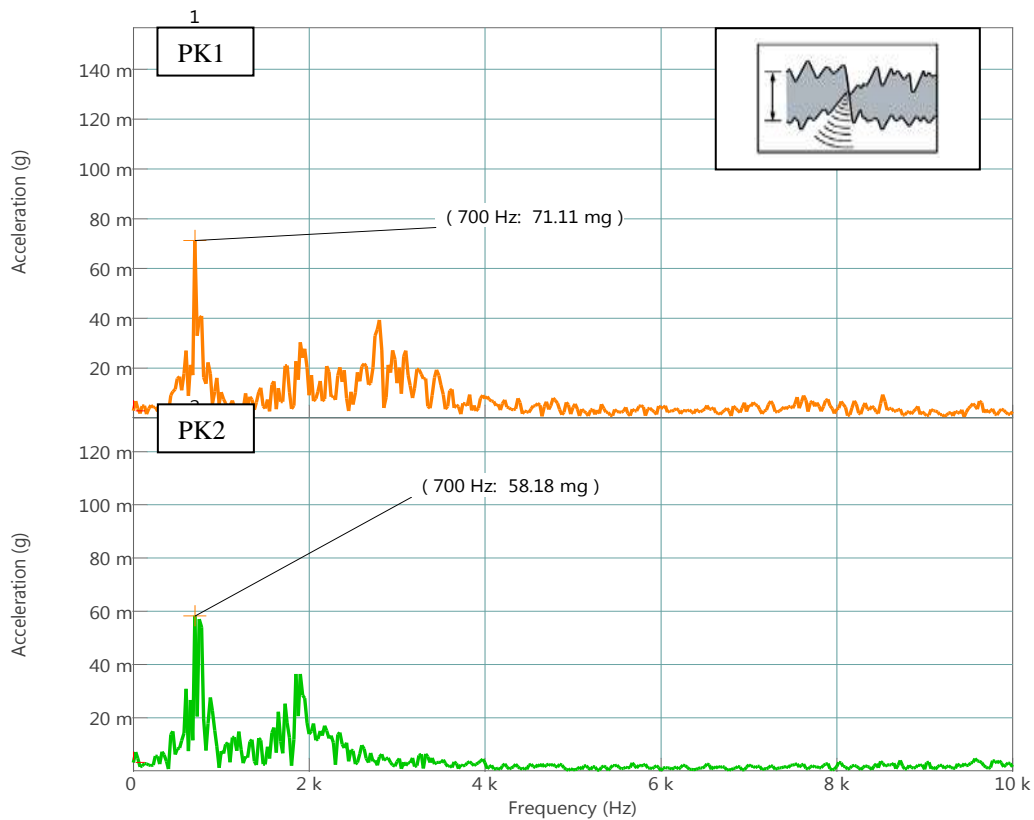
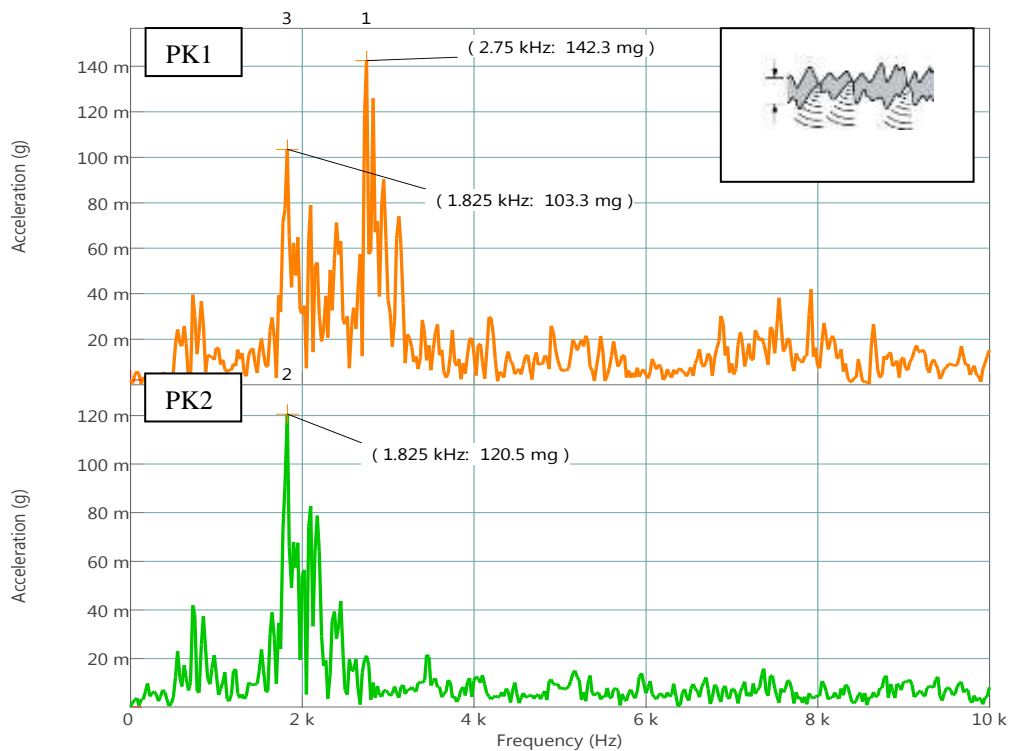
Fig. 4 Vibration acceleration spectra with grease lubricant (a) and without grease lubricant (b), with preloads $F_1=100$ N: PK1 transducer output upper and PK2 transducer output lower plots

The vibration acceleration spectra acquired from acceleration-time signals (Fig. 3, a, b) are shown in Fig. 4, a, b. Outer and inner ring raceways and balls stochastic vibration were damped by the grease. Vibration acceleration spectra (Fig. 4, a) indicated low frequency 700 Hz vibration acceleration amplitudes in the spectra of both PK1 and PK2 transducers output signals. This frequency was generated by $z = 9$ balls rotating about their own axes, but not of the micro-defect. The vibration acceleration spectra of dry bearing indicated dominating high frequency

of 2 750 Hz and 1825 Hz (Fig. 4, b). The high frequency of 2750 Hz vibration acceleration at 1.4 m/s² amplitude was measured with PK1 accelerometer indicated the first resonance frequency of the outer ring. The vibration accelera-

tion frequency of 1825 Hz indicated outer raceway and balls dynamic shocks excited vibration when bearing was tested without grease (Fig. 4, b).

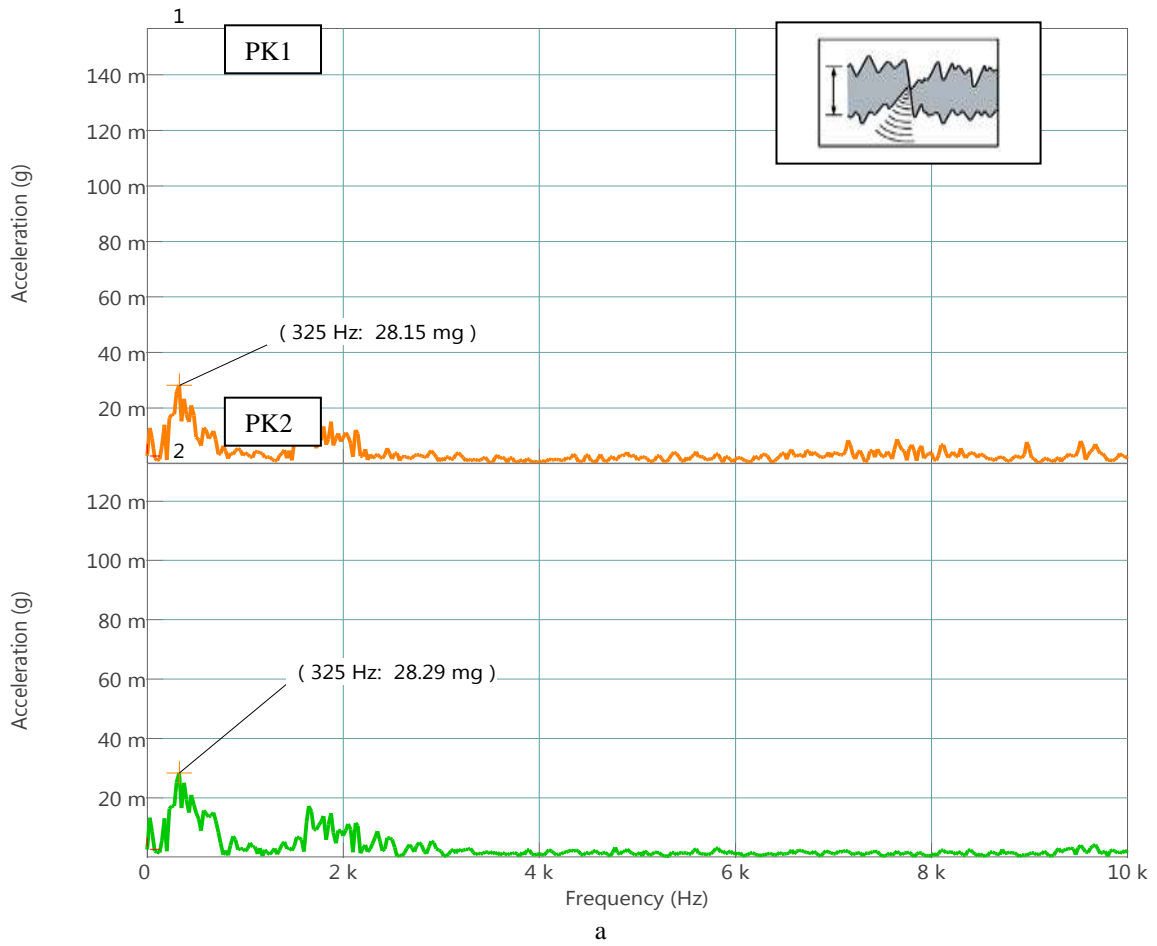
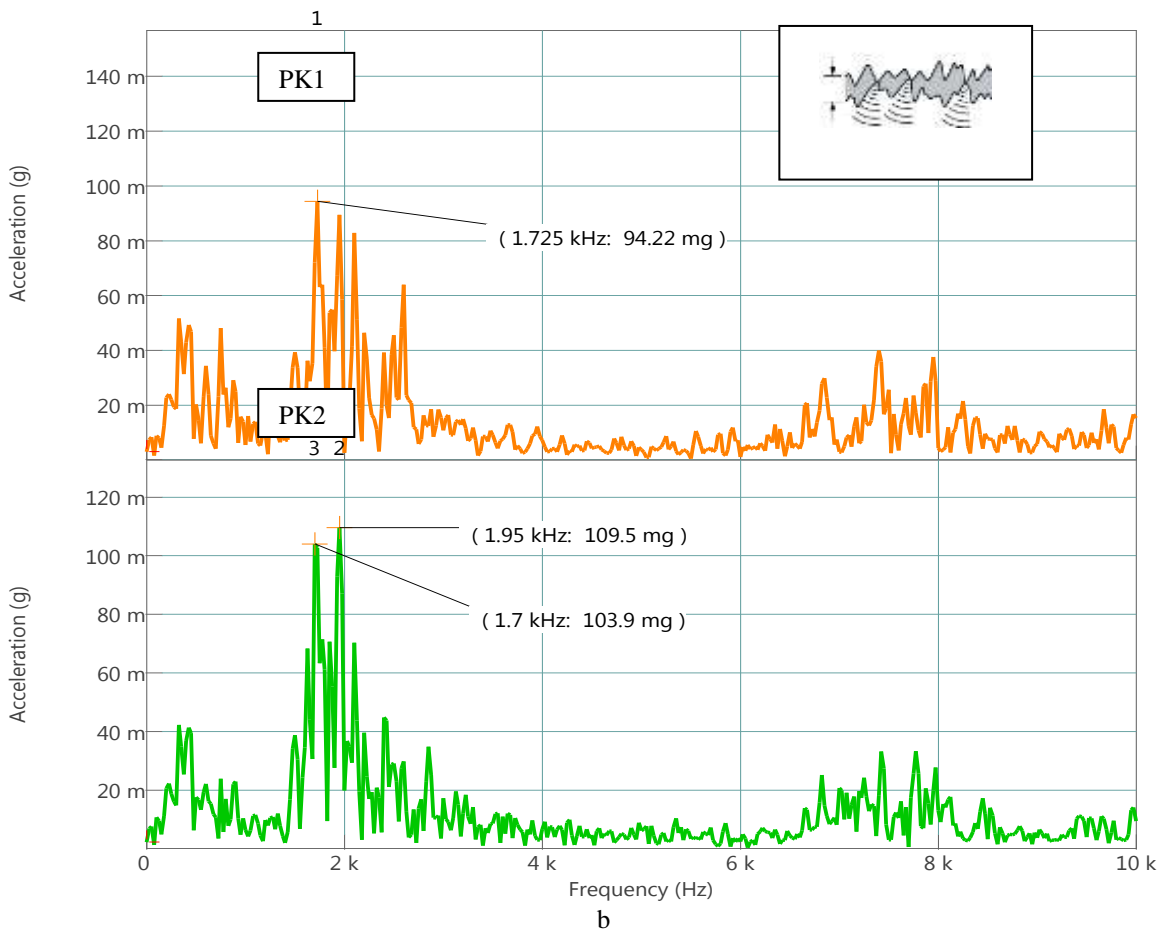
Fig.5 Vibration acceleration spectra with grease lubricant (a) and without grease lubricant (b) bearing without preloads $F_1=0$ N: PK1 transducer output upper and PK2 transducer output lower plots

With grease but without preloads $F_1 = 0$ N vibration acceleration magnitudes are ~3 times less in compari-

son with loaded bearings and shown in Fig. 5, a and dominated low frequencies 325 Hz. Vibration intensity is of the

same values measured with accelerometers PK1 and PK2. The vibration acceleration spectra of dry bearing indicated the dominant harmonics of high frequencies in the range from 1700 up to 2800 Hz including outer ring resonance frequency (Fig. 5, b). These high frequency vibration accelerations are generated by shocks of outer and inner

raceways and balls micro-defects, were characterized by maximum roughness depth R_{zMax} . The low frequency magnitudes were negligible. The vibration acceleration frequency 1700-2750 Hz indicated outer raceway and balls dynamic shock frequencies, resonance when bearings were tested without grease (Fig. 5, b).
